WURLITZER

Organ Notes

FREQUENCY RESPONSE - MODEL 500 TONE CABINET

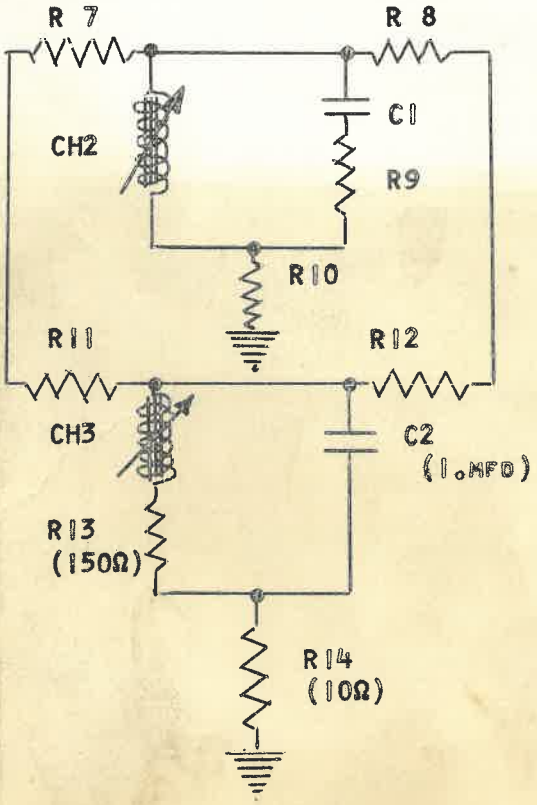
BEFORE CHANGE

UNDER CERTAIN ACOUSTICAL CONDITIONS, A LACK OF PROPER RESPONSE MAY BE NOTED ON MODEL 500 TONE CABINETS BELOW SERIAL # 393501. THE FREQUENCY RESPONSE CAN BE ALTERED BY CHANGING THREE COMPONENTS IN THE AMPLIFIER AS SHOWN ON THE SCHEMATIC DIAGRAMS BELOW.
